Correlation of electrical resistance to CMC stress-strain and fracture behavior under high heat-flux thermal and stress gradients

Matthew Appleby* †, Gregory Morscher*, Dongming Zhu†

39th International Conference and Exposition on
Advanced Ceramics and Composites. Daytona Beach, FL

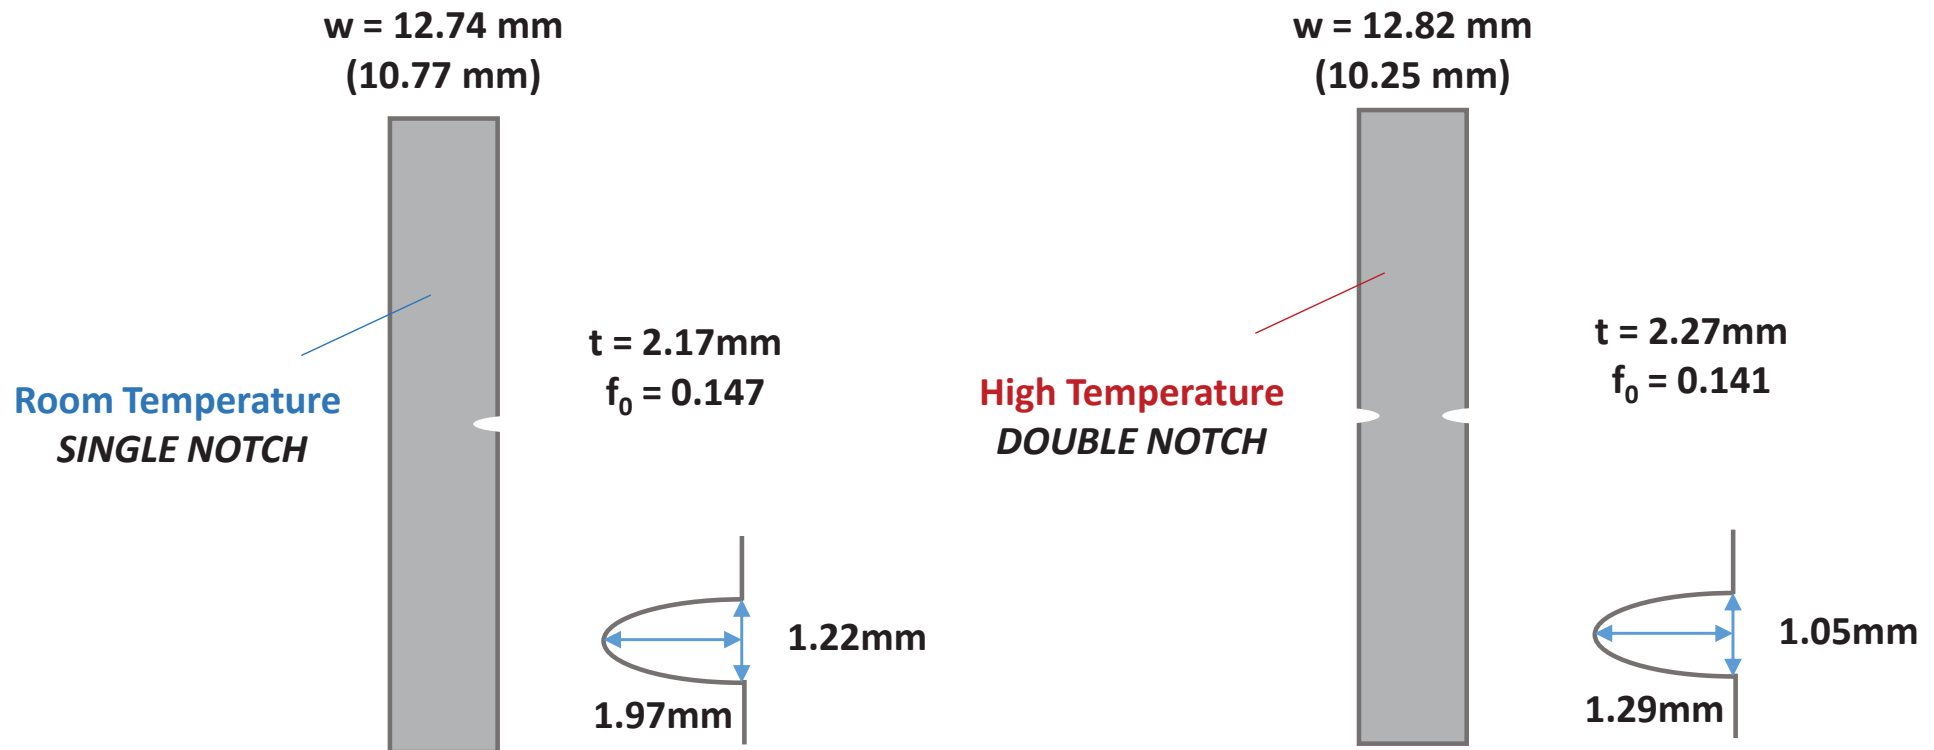
- SiC/SiC CMC material (Hyper-Therm HTC)
 - 8 plies, balanced 5 harness satin 2D woven 0°/90°, SiC/BN/SiC
 - Hi-Nicalon Type-S fiber reinforced
 - Produced by molten silicon melt infiltration (MI)
 - Machined into 6 in. tensile bars

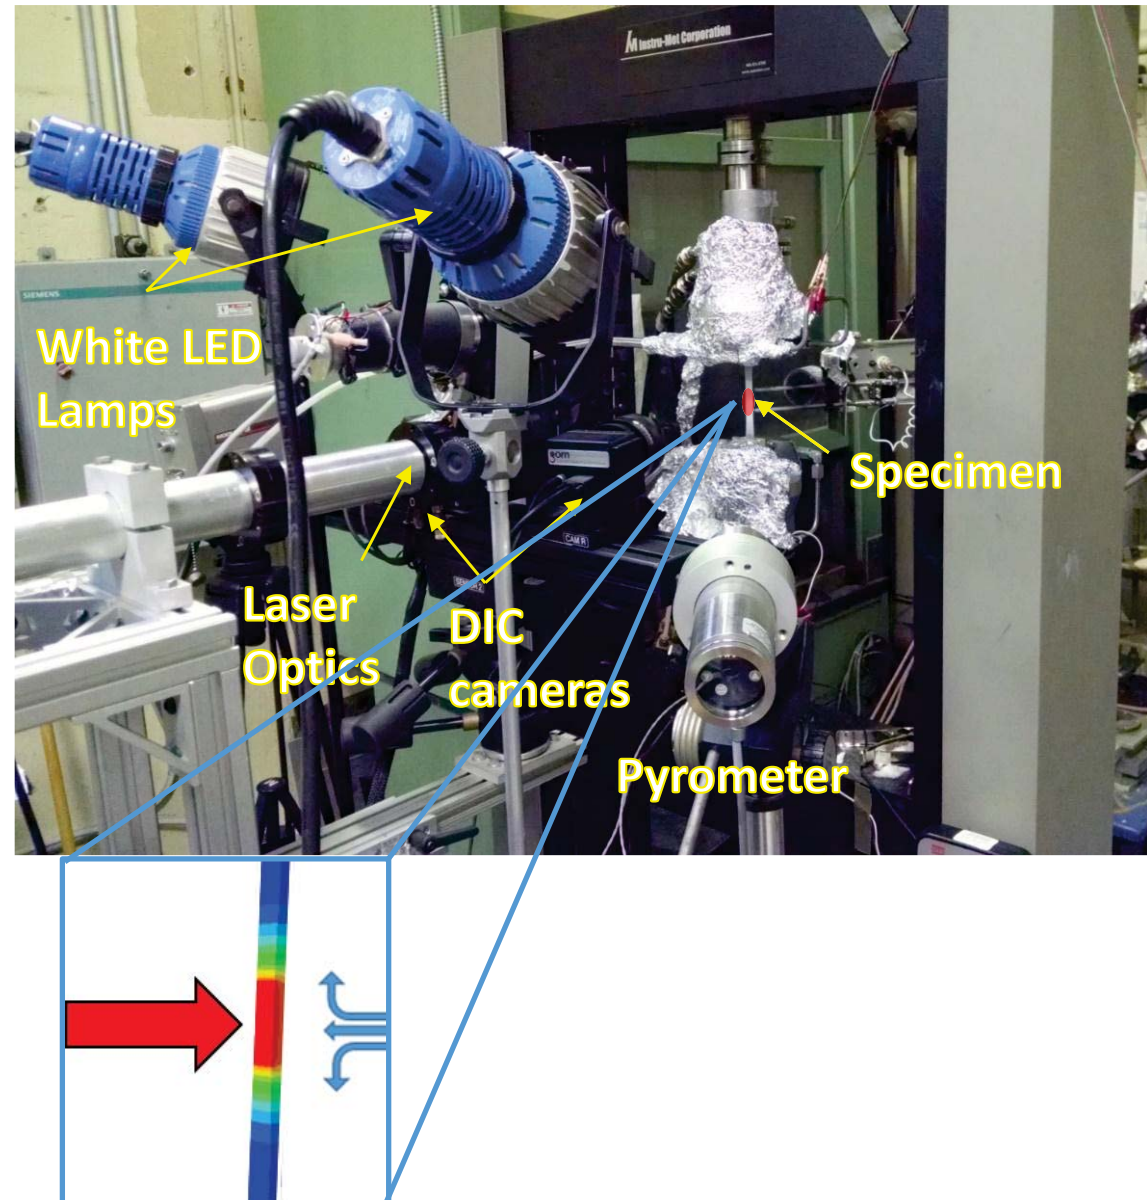
- Specimens are loaded in uni-axial tension rig
- Digital Image Correlation (**DIC**) is used to determine localized strain fields
- Nominal strain measurements are taken from using a 25.4 mm extensometer with a ± 0.5 mm travel
- **High temperature testing:**
 - Face of specimen gage-section heated by a 3.5kW CO₂ high heat-flux laser
 - Asymmetrical heating by laser generates thermal gradients (thru thickness and longitudinal)
 - Thermal gradients can be increased by the addition of active back side air-cooling
 - Front and back temperatures of the heated region are monitored by optical pyrometers

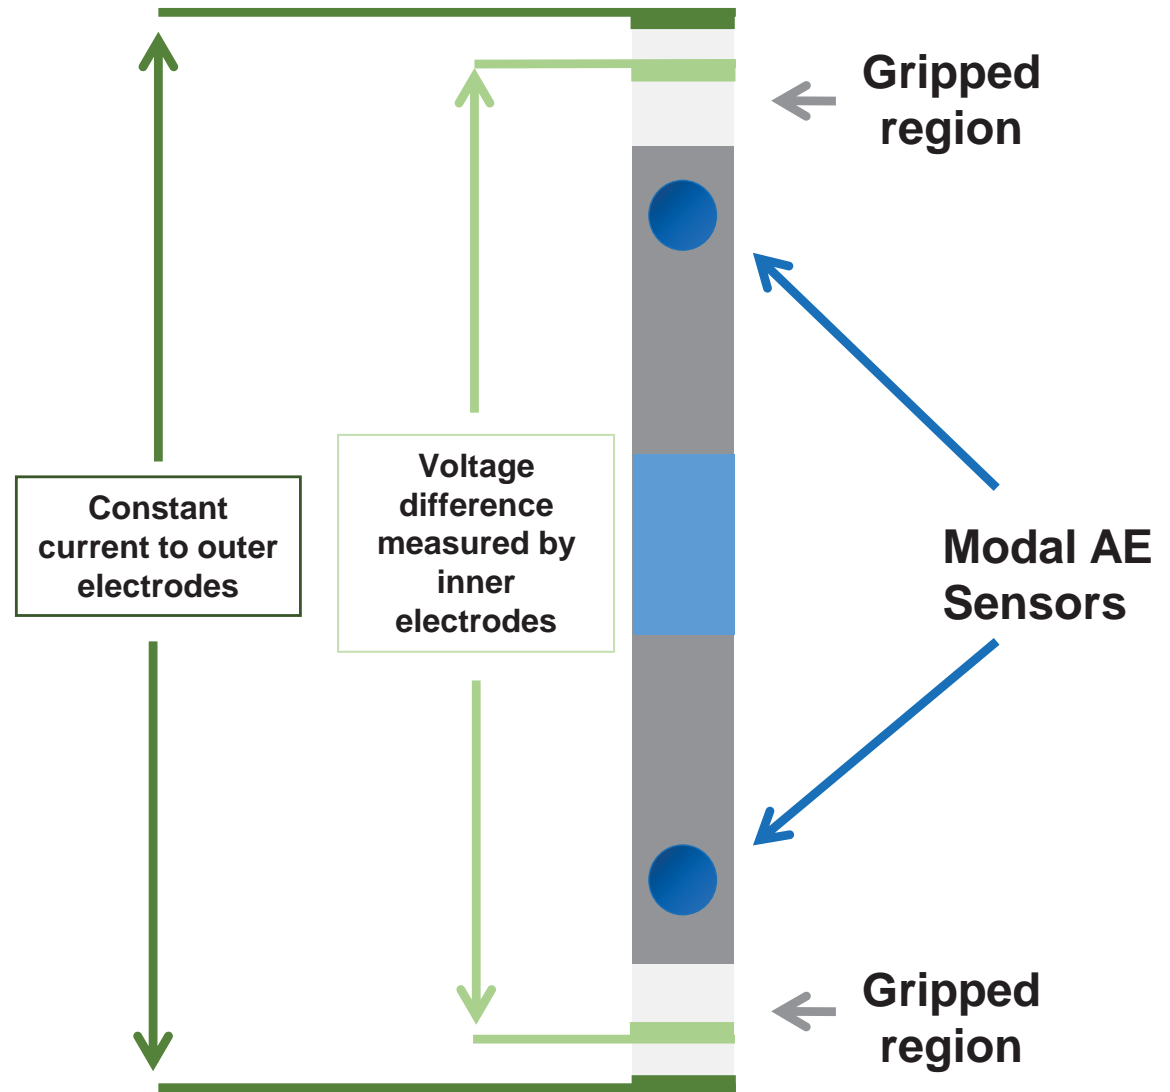
NDE Measurement

- Electrical Resistance (**ER**) measured by four-point probe method
- In order to avoid high temperature exposure during laser heating, **ER** leads for in-situ measurement are attached within the gripped areas
- Acoustic Emission (**AE**) sensors are attached ± 40 mm from center
- Post-test **ER** “inspection” is performed by taking discrete measurements along the specimen length

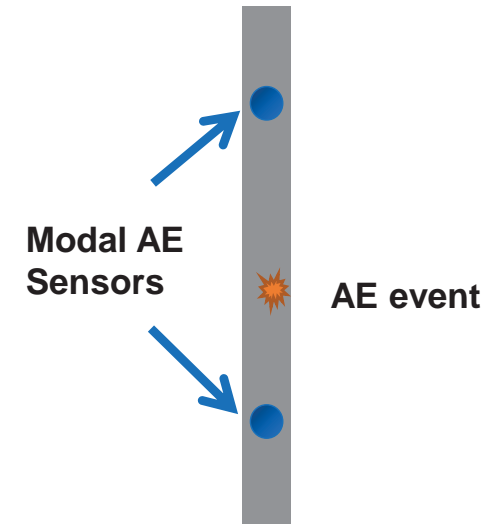
Modal Acoustic Emission Monitoring

- Fracture energy of solids released as elastic waves which are detected by the use of wide-band sensors in order to quantify stress-dependent cracking initiation and accumulation.
- Location of AE events estimated by the difference in arrival times of AE signals

$$x = \frac{v}{2}(t_{bottom} - t_{top})$$

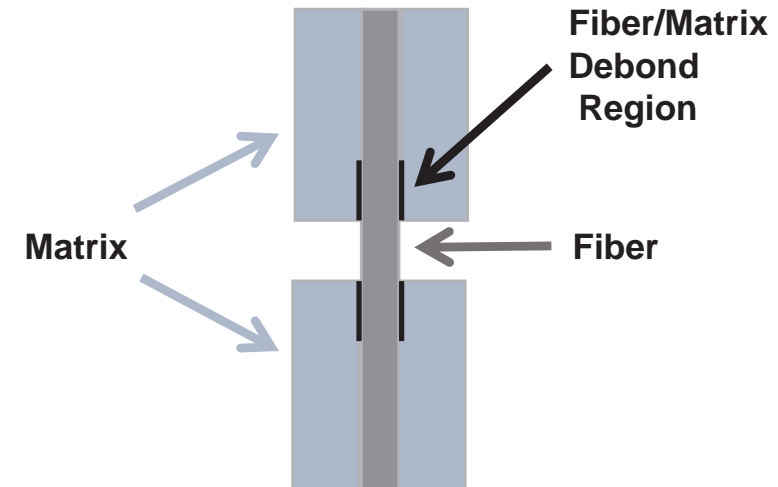
Electrical Resistance Measurement

- Damage in the form of matrix cracks and associated fiber debonding/sliding increase the overall electrical resistance of the composite specimen
- Matrix cracking of MI SiC/SiC is especially sensitive due to the highly conductive matrix formed from excess silicon deposits left from processing

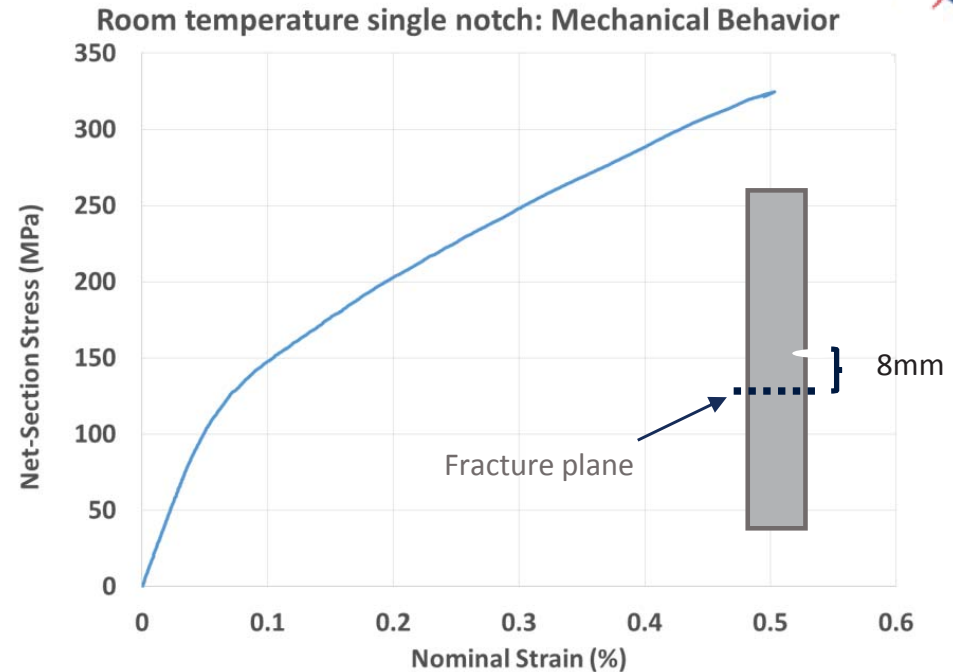
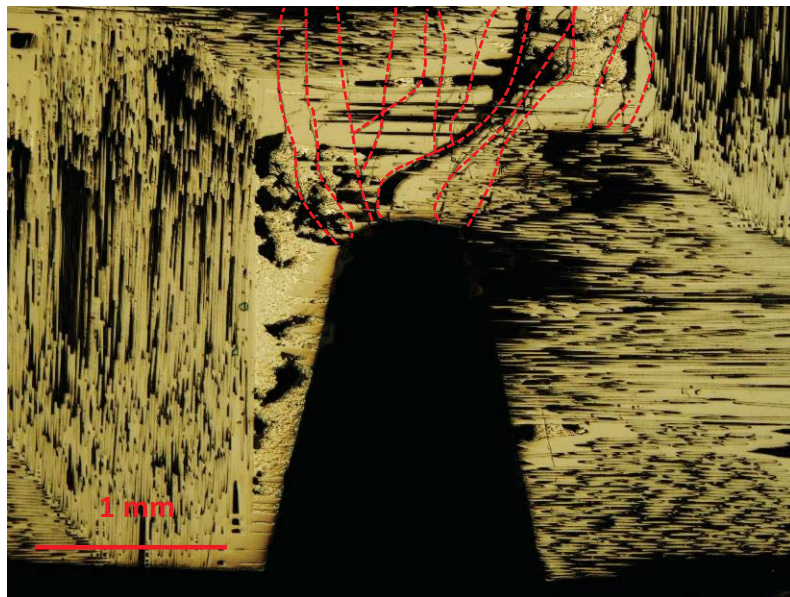
- Post-test microscopy revealed high crack densities in the vicinity of the notch, as would be expected from locally increased stress.
- However, due to a large density of porosity, another localized strain field was produced, leading to the ultimate failure location

Crack densities were therefore calculated for the notched region and the far-field regions

-12.7mm < x < -5mm	± 5mm	5mm < x < 12.7mm
Crack Density, mm ⁻¹	2.1	2.5	1.70
(far-field/notch)	(0.85)	1	(0.68)

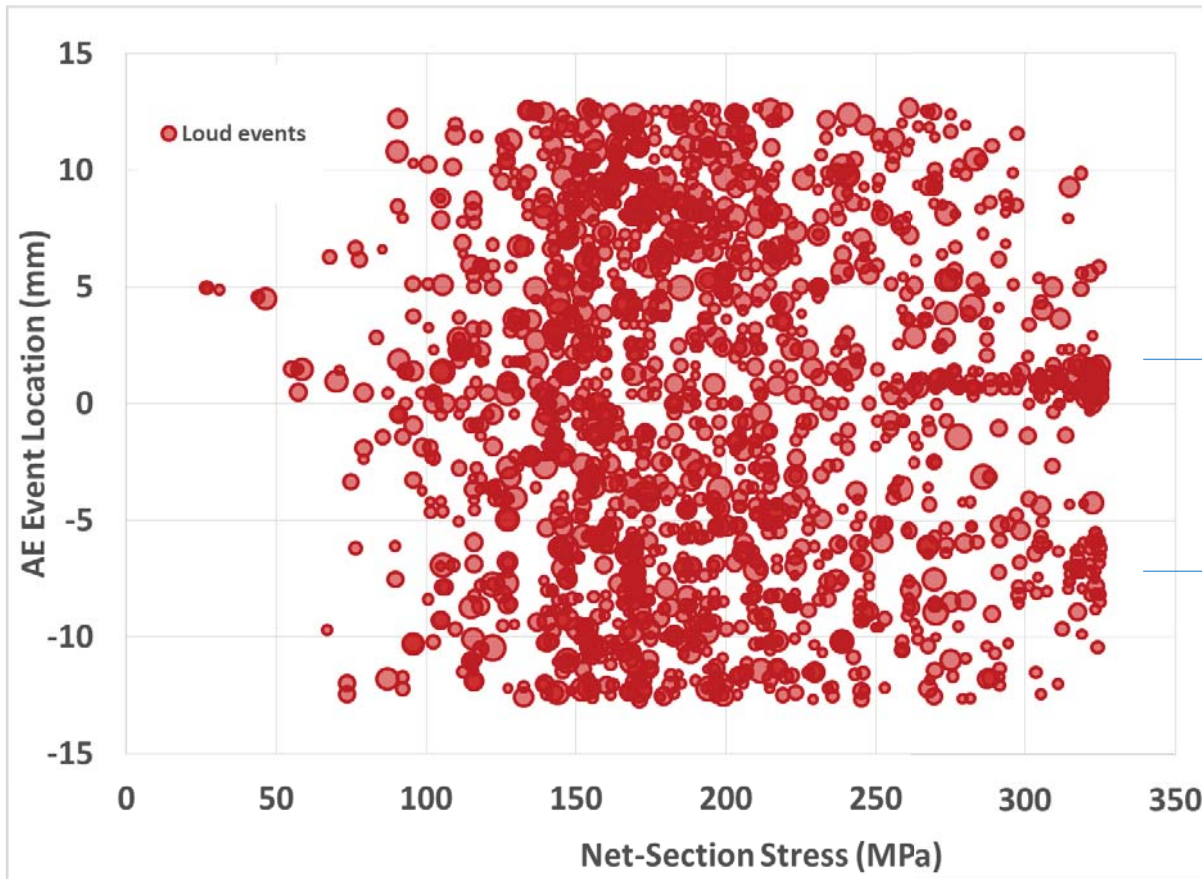
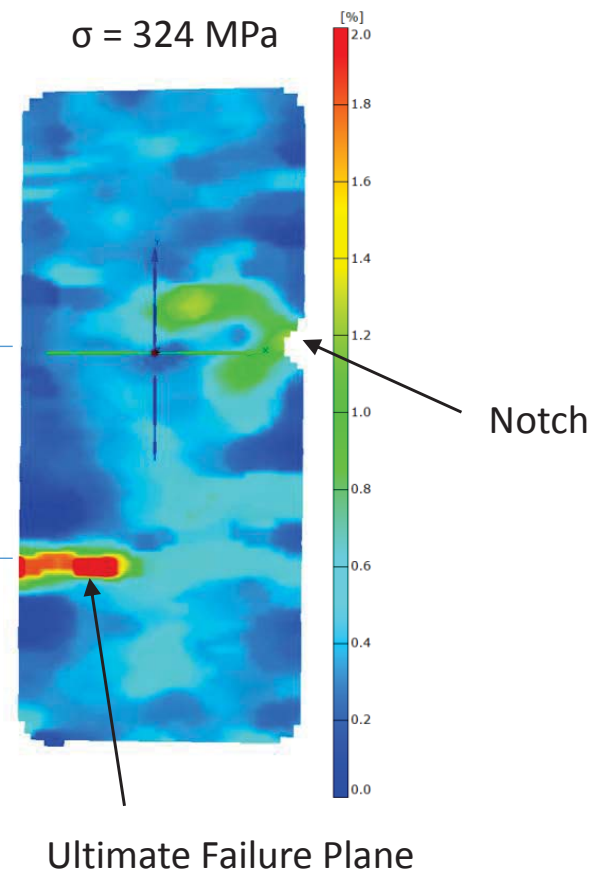
Damage Location

- Damage location determined from AE events in good agreement with DIC strain-field mapping of gage section at peak load

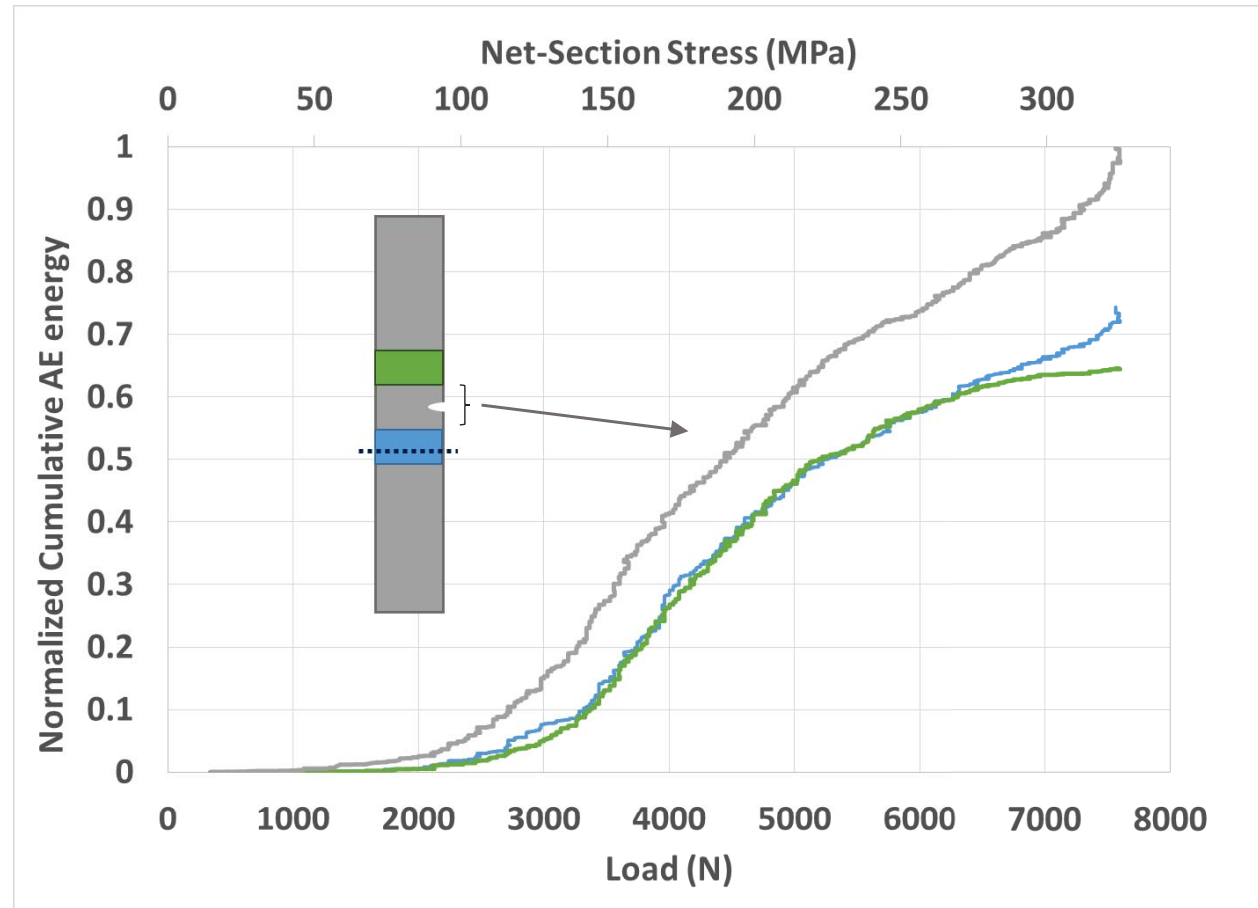
- Acoustic energy has been shown to be directly related to transverse matrix cracking in CMCs
- AE events separated by each region
- The cumulative energy was normalized in all regions by the total energy recorded in the notched region ($\pm 5\text{mm}$ from mid-plane of specimen)
- The area around the notch shows increasing damage at lower stress and higher total energy released; which is in good agreement with AE/DIC location analysis

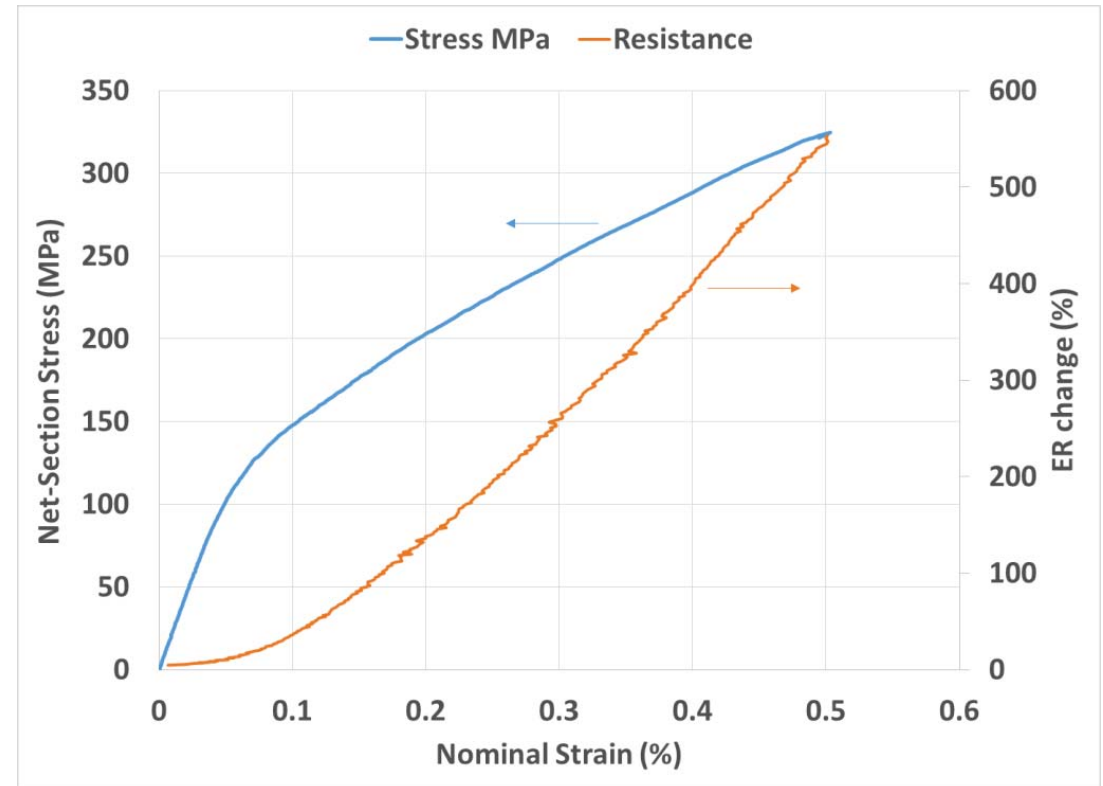
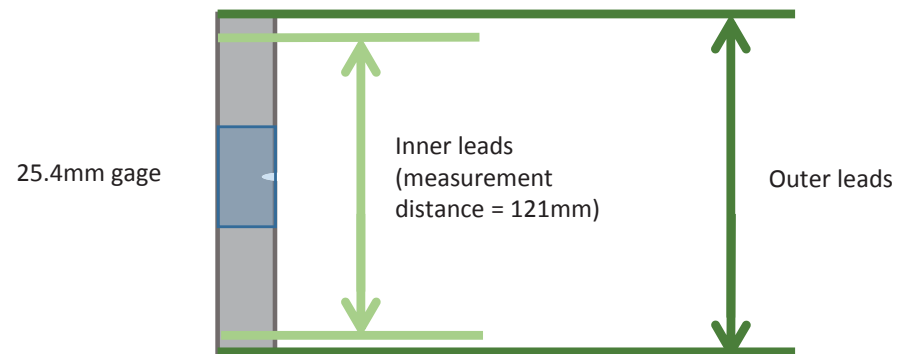
- While the elastic region shows little increase, ER begins to increase rapidly with damage onset.
- The electrical resistance of the entire specimen increases over 500% with an increase in nominal strain of the gage section of 0.5% at failure.
- ER is monitored over the entire specimen showing both the contribution to localized and far-field damage (including all matrix crack and fiber sliding)
- However, as previously noted, the damage accumulation is being dominated by the stress concentration region

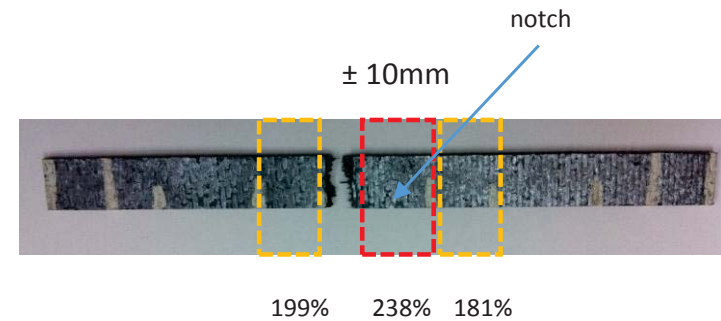
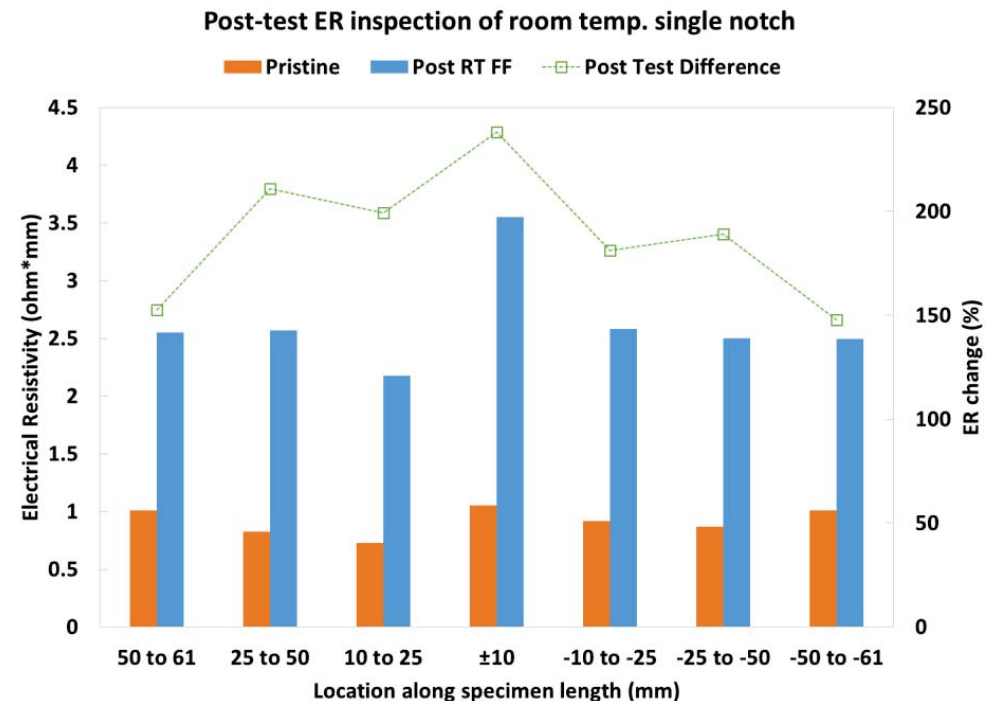
Post-test ER inspection

- In order to determine the contribution of ER increase from the gage region vs. the rest of the specimen, discrete ER measurements were taken along the length of the sample for the “pristine” and “post fracture” cases.
- As expected, the results show that the highest ER increase corresponds to the area of increased damage in the gage section

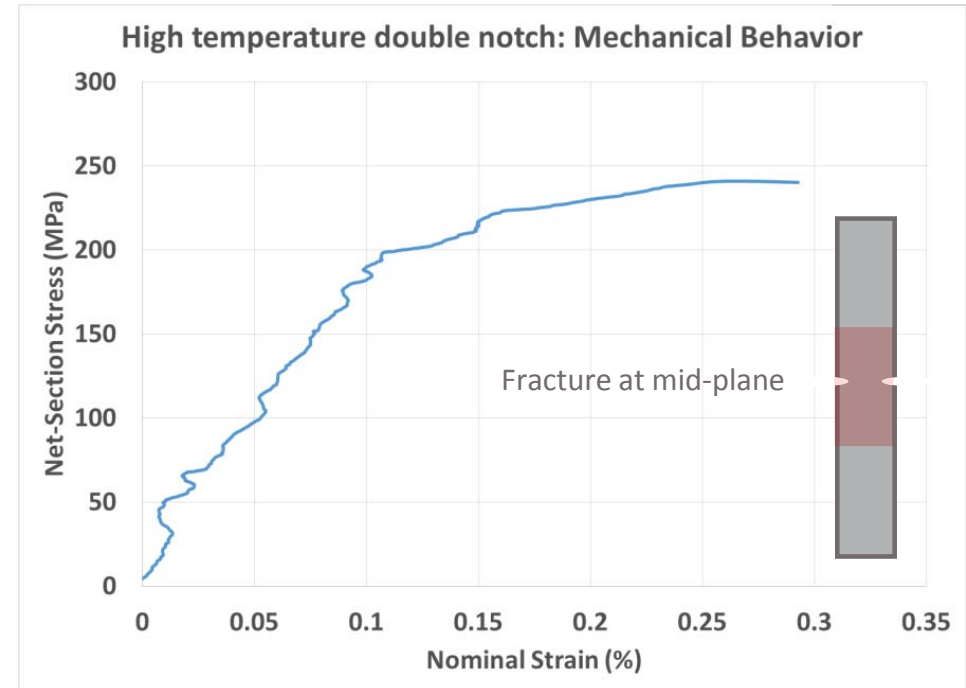
➤ Laser-heated gage section

$$T_{\text{surface}} = 1230^{\circ}\text{C}$$

$$T_{\text{back}} = 1000^{\circ}\text{C}$$

- 0.53% nominal strain increase from thermal loading, with an addition 0.29% nominal mechanical strain to failure
- Specimen failed along notch plane, with post-test microscopy showing increased crack density in notch region
- Specimen exhibits far less damage accumulation than room temperature (single notch) specimen

± 5mm	± 5mm < x < ± 12.7mm
Crack Density, mm ⁻¹	1.0	0.81
(far-field/notch)	1	(0.81)

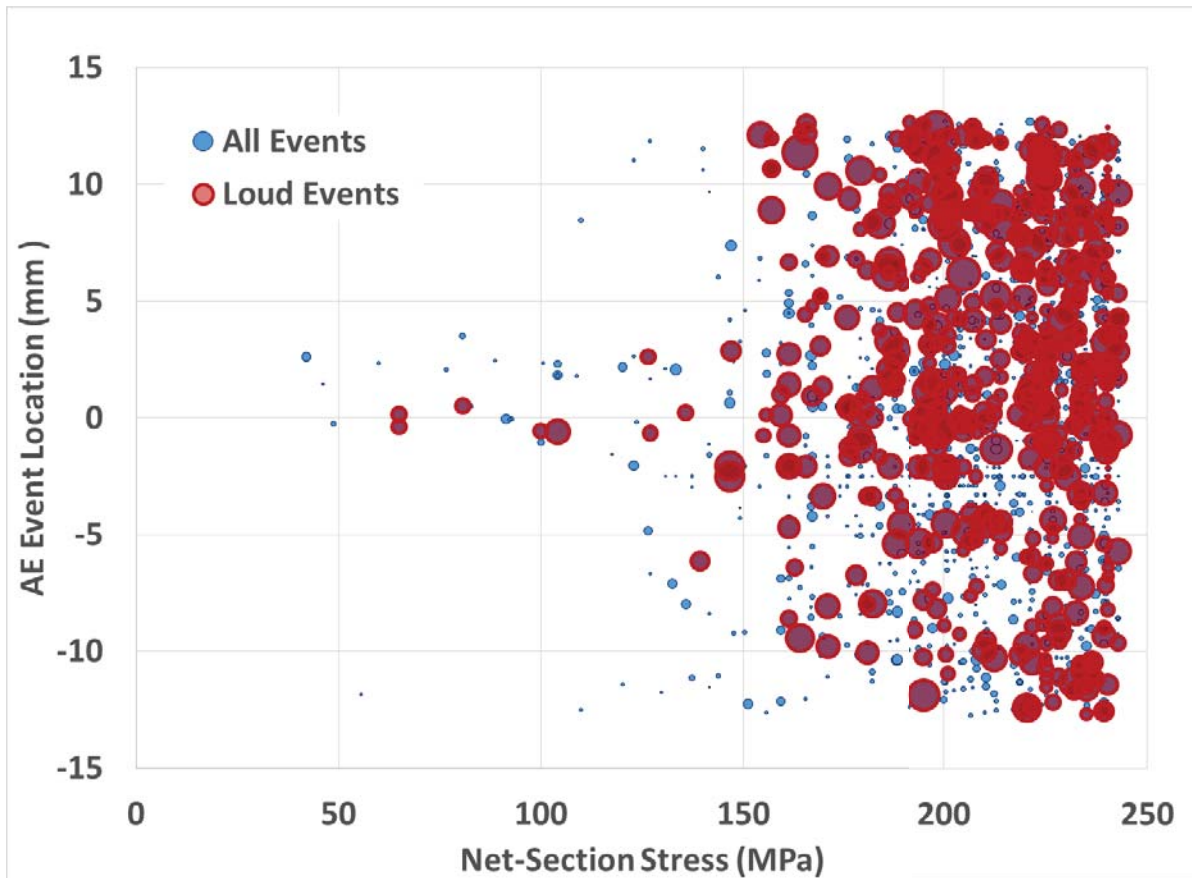
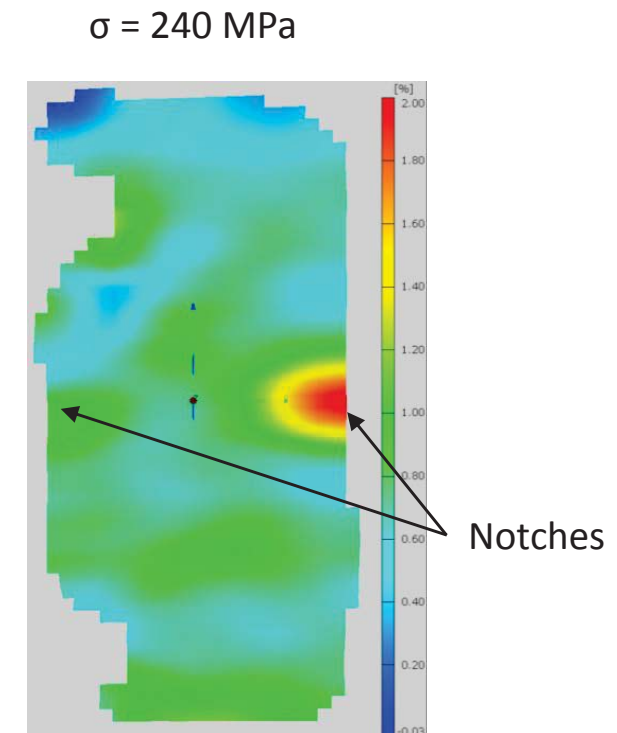
- Once again damage location determined from AE events in good agreement with DIC strain-field mapping of gage section at peak load
- At low stresses, AE activity occurs only in the notch region ($\pm 5\text{mm}$), while only becoming significant in the far-field above 150 MPa

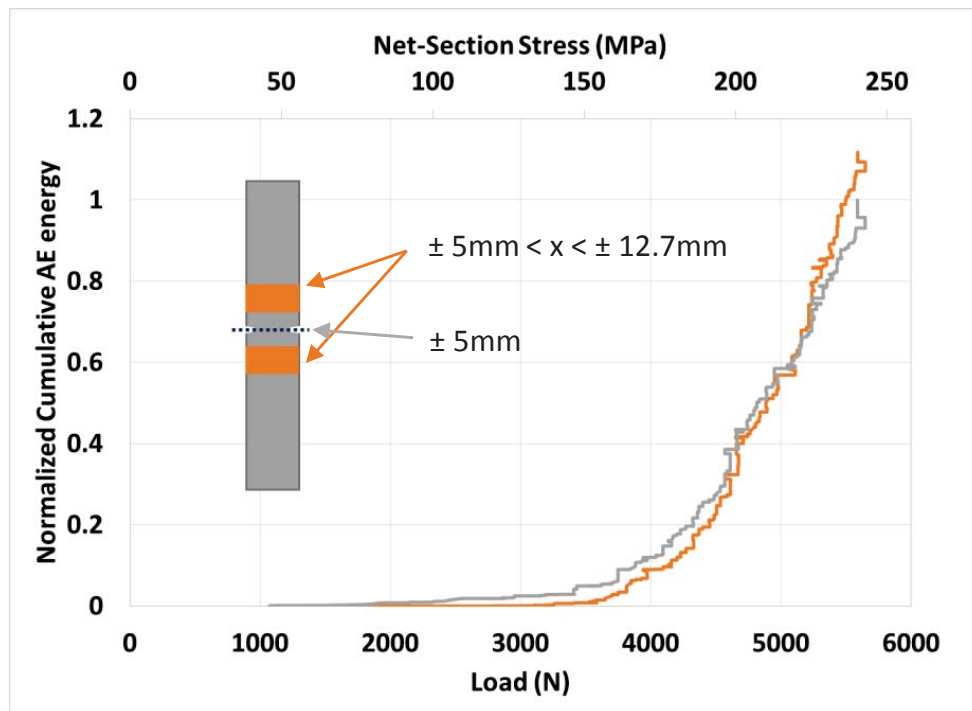
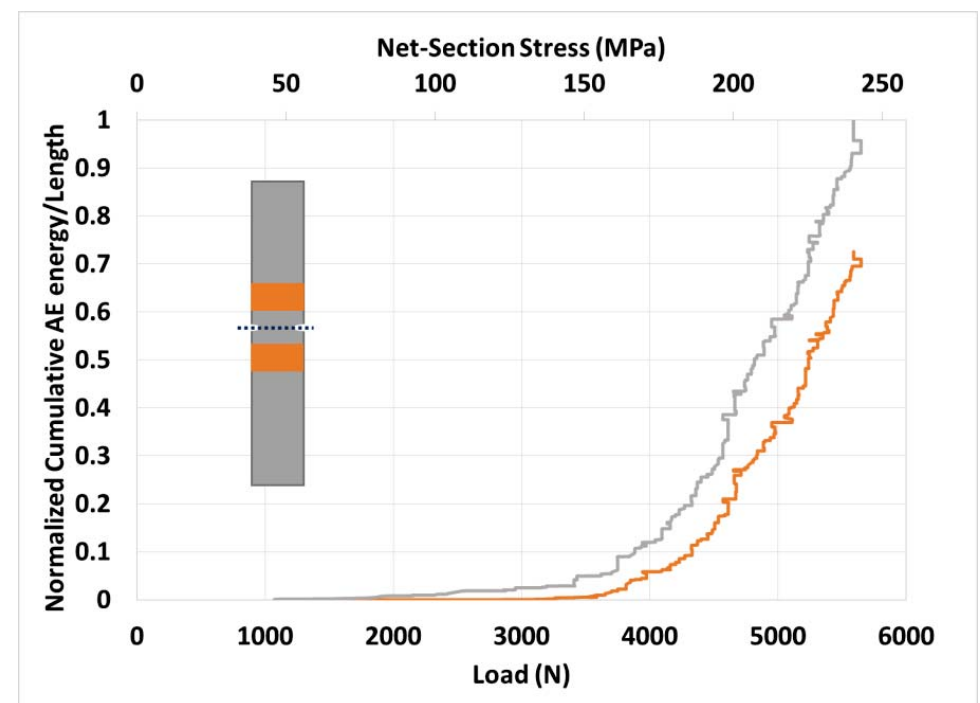
High Temperature - Damage Growth: Notch vs. Far-Field

- Similar to the room temperature specimen the area around the notch sees an increase in AE energy at a lower load level
- However, this sample does not reach matrix crack saturation, leading to the decreased values in matrix crack density in both the notched and far-field regions (as compared to room temp. test)
- Normalizing by their respective lengths you can see that the region outside the notch has a lower energy density (73% of notch region), which is in good agreement with the reported crack density measurements

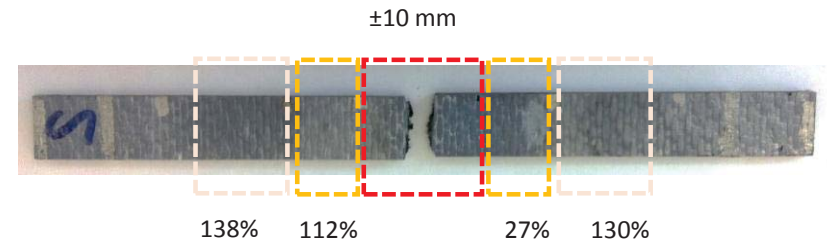
- Room temperature inspection of high-temperature tests
- The post high-temperature fast-fracture ER inspection analysis did not demonstrate the highest ER increase around the notch region as expected
- This seemingly anomalous behavior was further examined by observing the ER response to laser-heating only (i.e. no mechanical loading) to similar temperatures

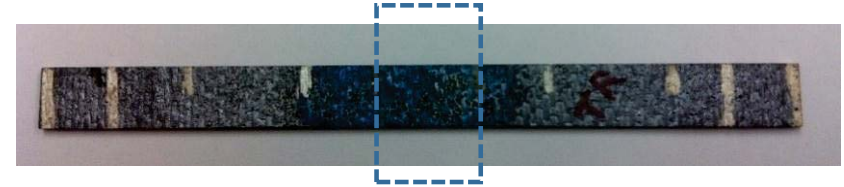
Post-heat ER Inspection

- Post-heat only data shows an increase in electrical conductivity of the heated zone upon cooling back to room temperature
- Clearly more needs to be understood about high temperature microstructural changes in the matrix (relief of residual stress, diffusion of impurities, etc..)
- Competing factors between high temperature exposure and damage could lead to good area for further development
